## MARYLAND HISTORICAL TRUST

#### R-ELIGIBILITY REVIEW FORM

BA 2693

#### Gwynnbrook Avenue Bridge

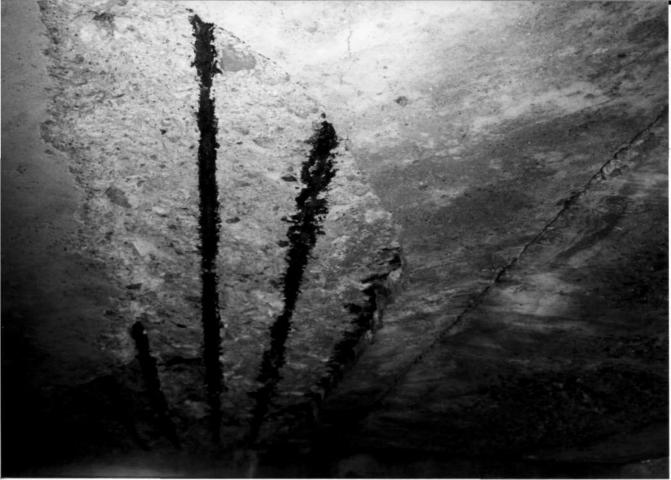
Concrete Slab: The continuous asphalt-wearing surface is lightly worn. Moderate to severe honeycombing is exhibited on the north side of the widened portion of the bridge. Near the northern end of the original structure, there is a 10'-0" x 4'-0" hollow sounding area of concrete in the soffit. Within this hollow are there is a 6'-0" long x 5" wide x 3" deep spall with exposed reinforcing steel. Severe efflorescence and stalactites have formed at the joint between the original structure and the south widened portion. The ½ inch wide joint at the widened portion of the bridge has vertical displacement of 1-1/2 inches. There is a 3" diameter x 6" deep spall adjacent to the south parapet. The concrete in the southern widened bridge portion is hollow sounding and exhibits moderate cracking with severe efflorescence.

Wing walls and soffit: Spalling, scaling and hairline cracking are exhibited on the wing walls. The soffit exhibits numerous minor cracks and moderate to severe honeycombing.

BA 2693 Gwynn brook Avenue Bridge Baltimore Gonty, MP photographer: Larry Murphy Dato of Photo: 4-6-641 Location and Alegative: MOSAPO Spalls, Exposed Rebard : Cracking in Bridge Deck Soft it 2 photo -30f6

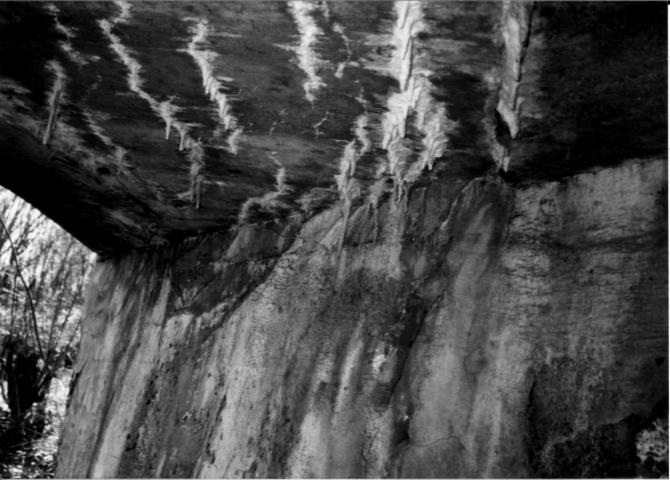
BA 2693 Gwynbrook Avenue Bridge Baltimore County, MD photographer: Larry murphy Date of Photo: 4-6-04 Location of Hegative: MO SHYD Heavy's Effloresænce and stalactites In Bridge Deck 30 ffit Photo 40+6

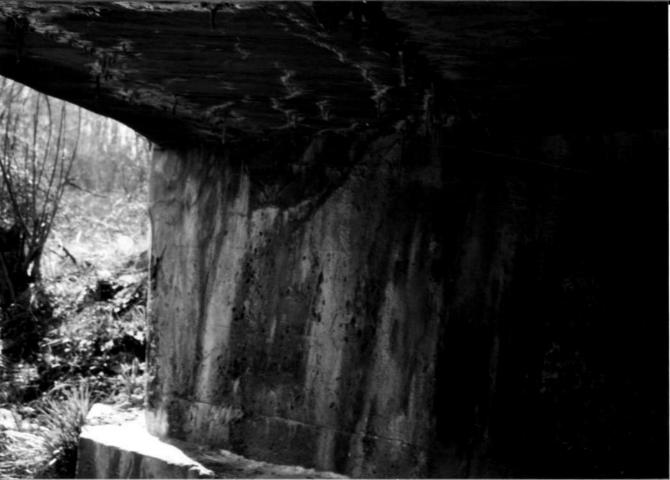
Reinforced Concrete Abutments: The concrete abutment stems both exhibit several full height hairline cracks and hollow sounding areas. The entire length of the west stem exhibits severe scaling and exposed aggregate. The south half of the west stem exhibits 1/16" hairline diagonal and vertical cracks with severe efflorescence within the widened portion of the stem. There is approximately 1-1/2" to 2" of separation between the original and widened portions of the east abutment at the north end of the abutment. The north half of the east stem exhibits moderate to severe scaling with exposed aggregate. The original concrete in the stem at the southwest and northeast ends respectively, of the abutments is hollow sounding. The south end of the west footing is heavily worn where the stream flows against it. A 1' x 1' area of the west footing is hollow sounding.

BA 2693 Gwynbrook Avenue Bridge Baltimore County, MD Photographer: Larry Murphy Station of negational and and son pounce Scaling In west Abutment Stern and cracked at widening interface. photo 5 of 6

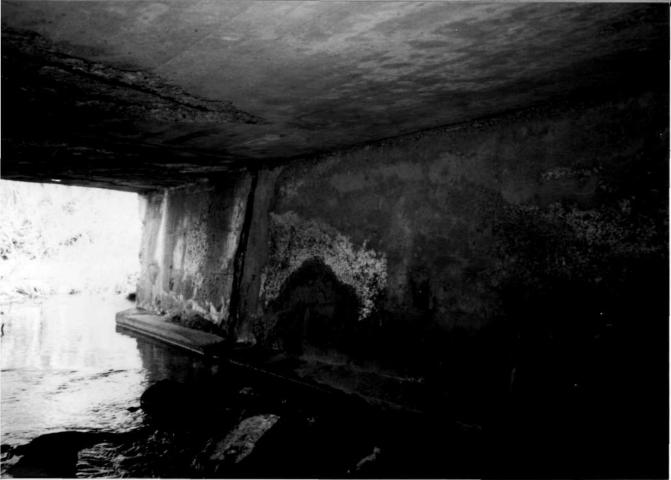
BA 2693 Gwynn brook Avenue Bridge Baltimore County, MD photographer: Larry Murphy Photo Pate: 4-6-04 Location of Negative: MD SHPO Scaling in cast about ment stem and Crack at widening sourface. Photo 6 of 6
